The XTS-W+ from AMOT is a bearing condition monitor for 2-stroke low speed engines. It indicates wear in the primary crank train bearings: main; crankpin; and crosshead. In addition it monitors both water in oil content and electrical potential between the propeller shaft and hull, both of which may have an adverse effect on bearing life.

## Avoid open-up inspections & protect the heart of your engine with the XTS-W+

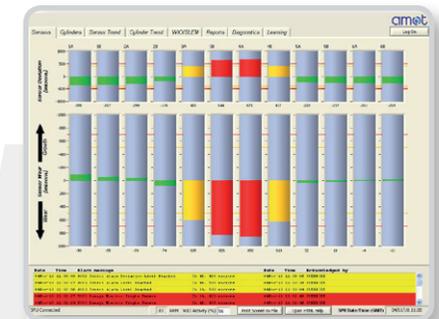
- Bar chart showing 'real time' wear, 3 alarm conditions: green = good, yellow = warning red = alarm, flashing red = engine slow down

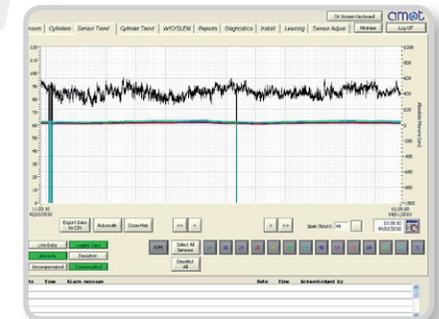
- Trend chart showing long-term wear trends
